# Damaged Insulation Mimicked Symptoms of Occipital Stimulator Lead Migration

Collin Clarke, MD, Parinaz Azari, MD, Billy Huh, MD, PhD

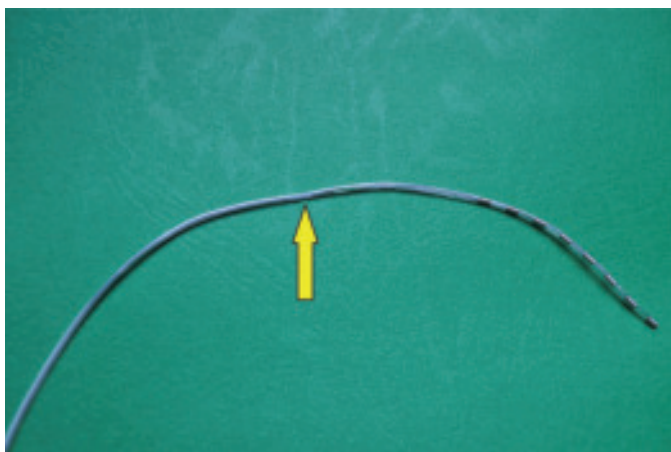
left sided stimulation. The patient continued to report excellent pain relief from her right sided stimulation. Coinciding with analgesic failure was the onset of intermittent left posterior neck triangle muscle spasm and associated burning sensations. Interrogation of the device did not show any alteration to impedance, with the range being from 427 to 557 Ohms. Stimulation settings were 00+–+00, frequency 120 Hz, pulse width 280  $\mu$ sec. Plain film X-ray of the lead sites did not demonstrate any significant migration of the lead from the original positioning. In light of the patient's symptoms the decision was made to optimize lead placement via revision. Following informed consent, the surgery was performed under combination of local anesthesia and intravenous sedation with the patient in prone position with the head slightly flexed. Following dissection through the previous anchor site, fluoroscopy guidance was utilized to isolate the left occipital lead (Octrode<sup>®</sup> 3181, St. Jude Medical, Plano, TX, USA). The lead had been anchored directly with a 2–0 silk suture to fascia in a similar manner to securing a chest tube. This had been a technique chosen in patients with thin cutaneous layers to decrease the bulk of the anchor site. The lead was removed and inspected. It was observed that the insulation at the anchor site had eroded, completely exposing the internal conducting wire (Figs. 1 and 2). A new occipital lead of the same model (Octrode 3181) was

**Figure 1.** The Octrode lead with arrow demonstrating the point of insulation erosion exposing the internal wires.

**Discussion:** Disruption of occipital nerve stimulator lead insulation may mimic lead migration with failure of neuromodulation, spasm, and local burning sensations. Prior to reimplanting, a lead should be thoroughly inspected to ensure there is no mechanical failure. Anchoring should be performed with gentle direct suturing or the use of a protective anchoring device.

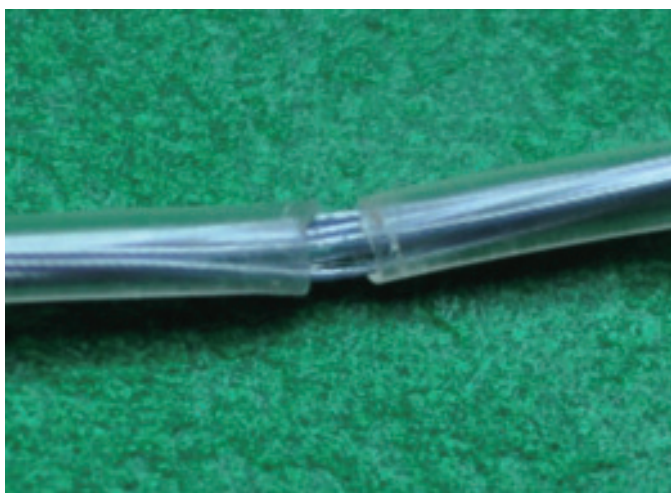
**Figure 2.** Close up view of the exposed internal wires at the site of insulation disruption.
